## **TRELLEBORG RESILIENT**

#### <u>TRELLEBORG</u> <u>ELITE-XP</u>

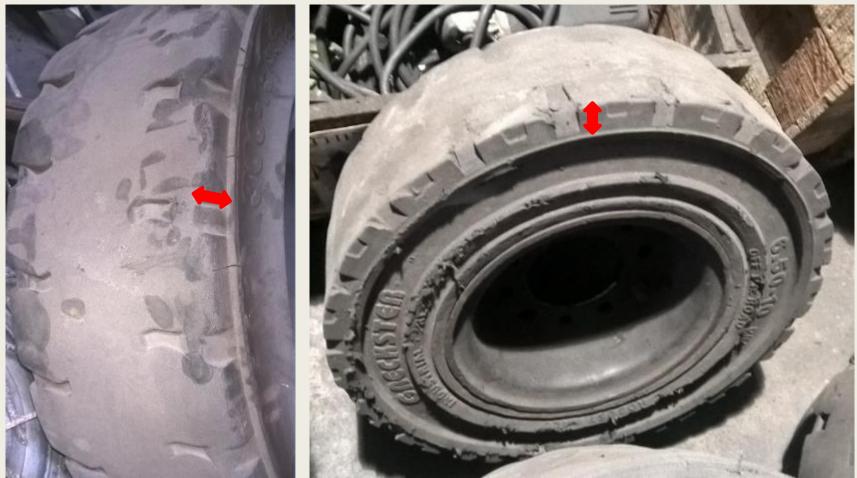
## **SIDEWALL CRACKING**

- Typically caused by inability to cope with the load
- Also due to poor construction

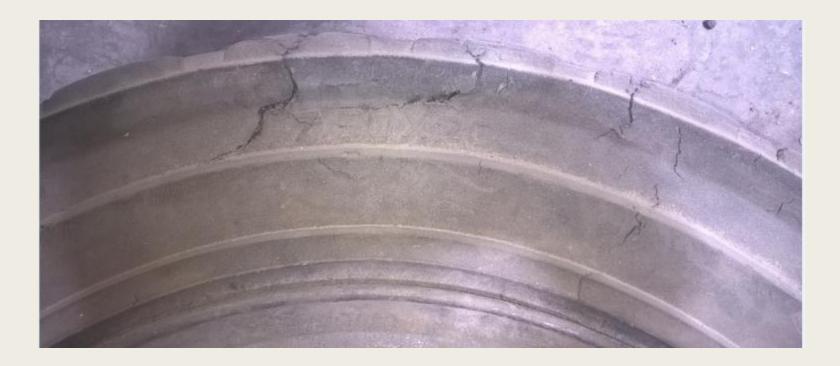
## **TREAD SEPARATION**

Middle layer (meant for shock absorption) made of rubber and coarse fiber (cheap option)
Heat build up separates the bonding between fiber and rubber leading to separation

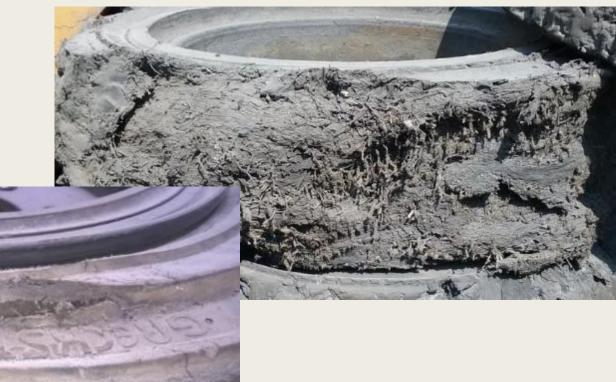
# LUG CHUNKING

- Because of Wide & Deep grooves
- Increased chance of entrapment of foreign objects
- Cracking at the base of lug Leads to lug chunking

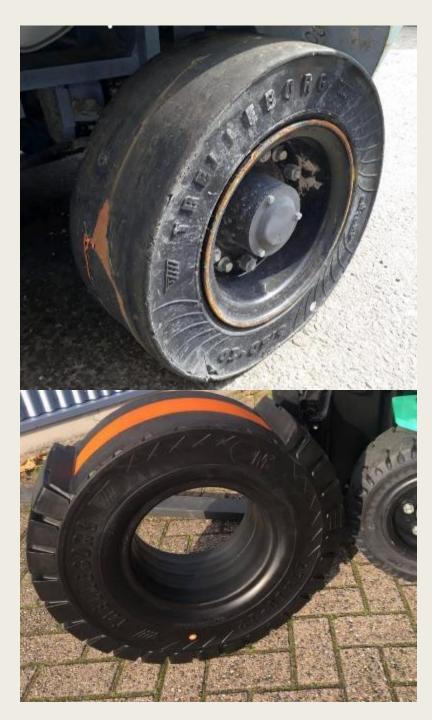
### TRELLEBORG ELITE XP THE PIT STOP LINE

- Bright orange under-tread wear indicator
- Maximum value by replacing tyres at the right time

- Allows ample time to schedule replacement at your convenience without compromising performance, safety or productivity.
